NASA Technical Paper 1481

Light Airplane Crash Tests at Three Pitch Angles

Victor L. Vaughan, Jr., and Emilio Alfaro-Bou

NOVEMBER 1979

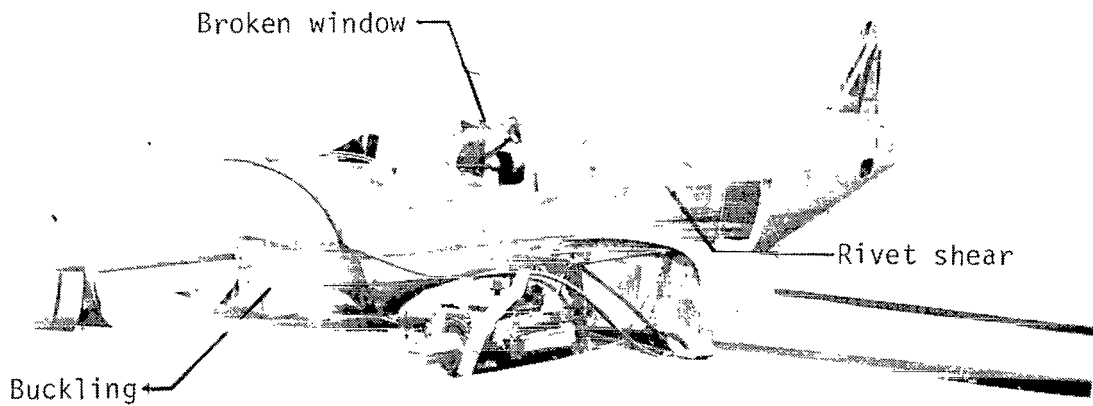
(a) Pitch-down test specimen.

Pitch-down test.— The photograph of the test specimen for the pitch-down test (fig. 12(a)) shows extensive buckling damage to the lower part of the fuselage from the nose to the fire wall, which was the primary impact area. The separation of the skin at the lower edge of the windows on the port side was caused by rivet-shear failure during the slam down or second impact. The window breakage also occurred at this time; however, the pilot's head impacting the window 0.165 sec into the crash (fig. 11(a)) may have contributed to side-window breakage.

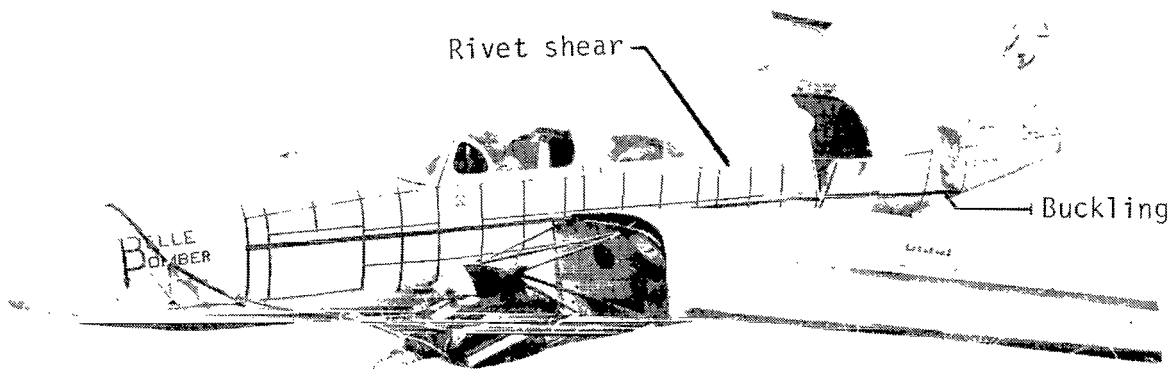
(b) Flat test specimen.

Flat test.— The photograph of the test specimen for the flat test (fig. 12(b)) shows only skin wrinkles in the forward section of the airplane specimen. The initial contact of the fuselage with the ground was in the vicinity of the door. The transverse expansion of the fuselage caused separation of the skin under the windows, as in the pitch-down test, but the degree of separation was less. More severe lower fuselage damage was sustained in the vicinity of the third window and extended rearward through the baggage compartment aft of the door (fig. 14). Separation of the skin along the bottom of the windows on the starboard side of the fuselage is shown in figure 14(a). As in the pitch-down test, the port side sustained more rivet-shear damage along the windows than the starboard side, thus supporting the conclusion that the door opening weakened the fuselage on the port side. In this test, the door opened immediately after the first ground contact.

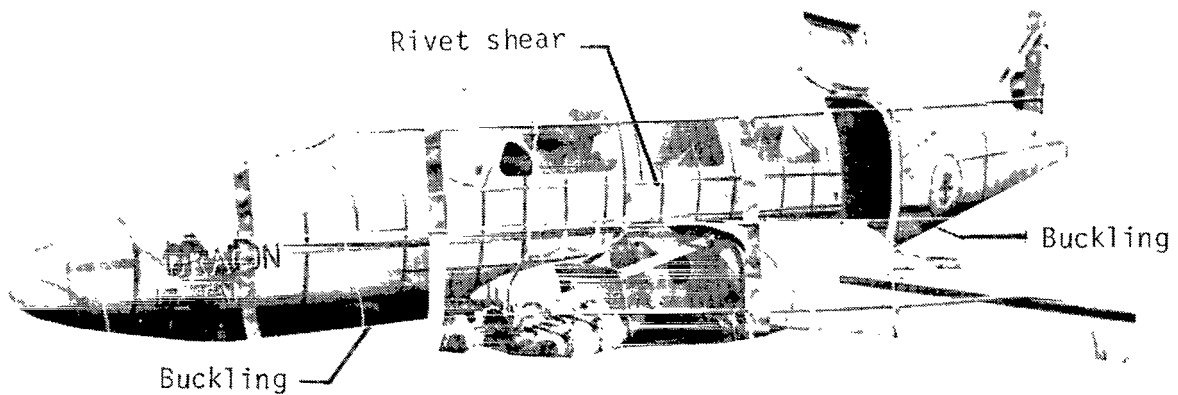
(c) Pitch-up test specimen.

Pitch-up test.— The photograph of the test specimen for the pitch-up test (fig. 12(c)) shows very little damage to the port side of the specimen. Small wrinkles or buckling can be noted at the nose near the fire wall and aft of the door. Separation of the skin under the windows due to rivet shear is shown in figure 15(a), but was not nearly as severe as in the pitch-down and flat tests. The primary impact occurred along the aft fuselage section at the baggage compartment. The separation and buckling of the skin on the bottom of the fuselage at the frame forming the aft edge of the door was a result of the tensile loading in the bottom of the specimen as the aft end of the specimen contacted the ground. Separation of the skin on the starboard side of the specimen is shown in figure 15(b). The door opened immediately after initial ground contact as it did in the flat test.

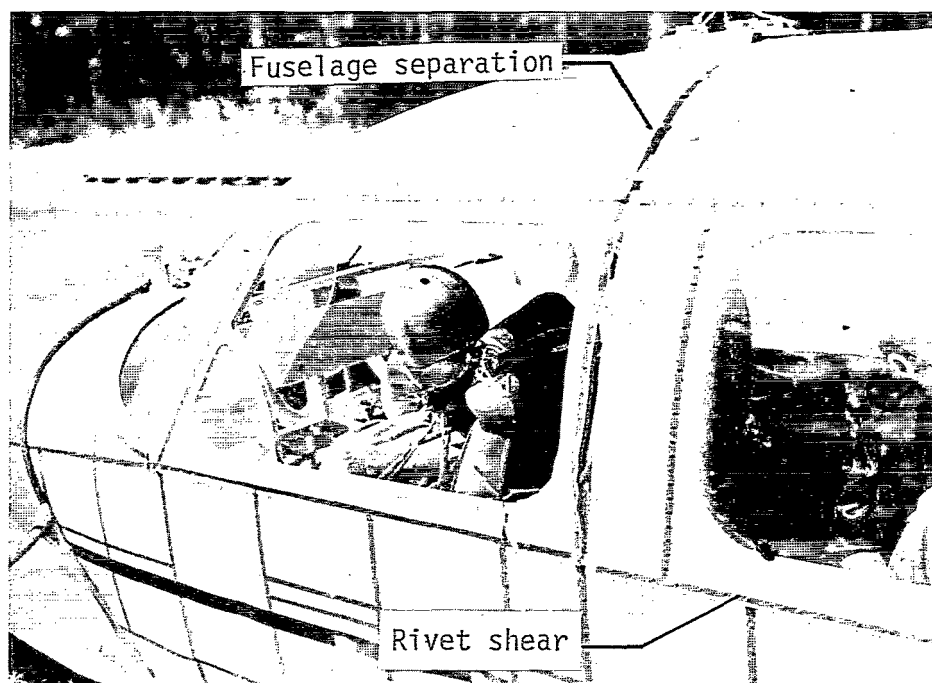
A close-up view of the window section of the specimen is presented in figure 13(a). The separation in the fuselage at the frame just aft of the pilot is directly over the main wing spar that passes through the fuselage. This separation occurred as the specimen tail reached its lowest position during downward rotation, which caused the top of the fuselage to go into tensile loading, thus shearing the rivets that attach the skin to the frame.

(a) Separation of fuselage on port side of fuselage.

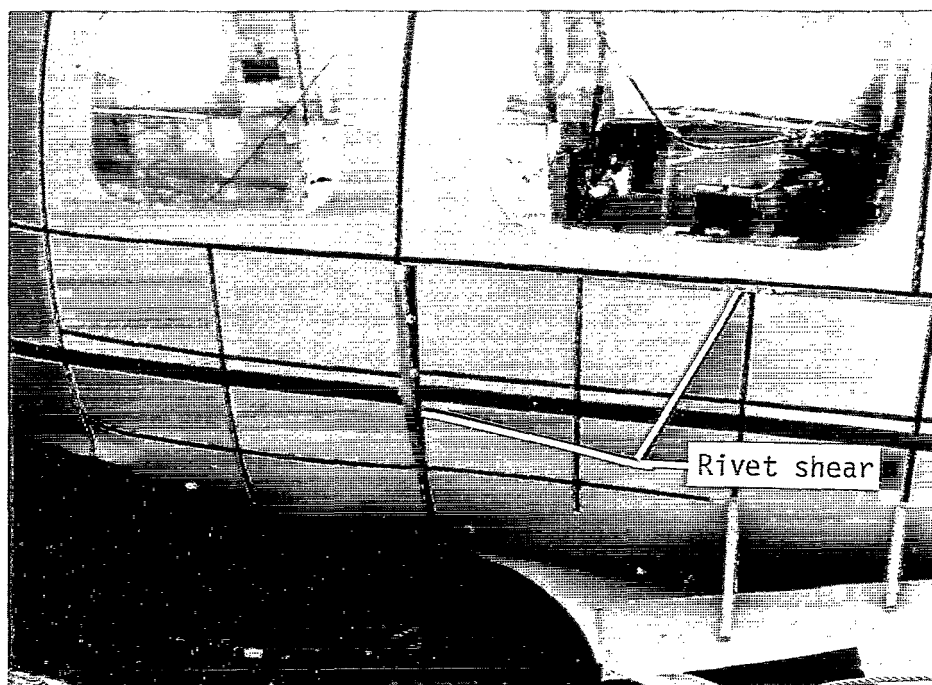
Figure 13(b) shows the rivet-shear failure under the windows on the starboard side of the fuselage. This type failure also occurred in the lower section of the fuselage on the starboard side at the frame forming the leading edge of the door on the opposite side. The greatest rivet-shear damage occurred on the port side of the fuselage (fig. 11(a) and fig. 13).

(b) Separation of cabin on starboard side of fuselage.

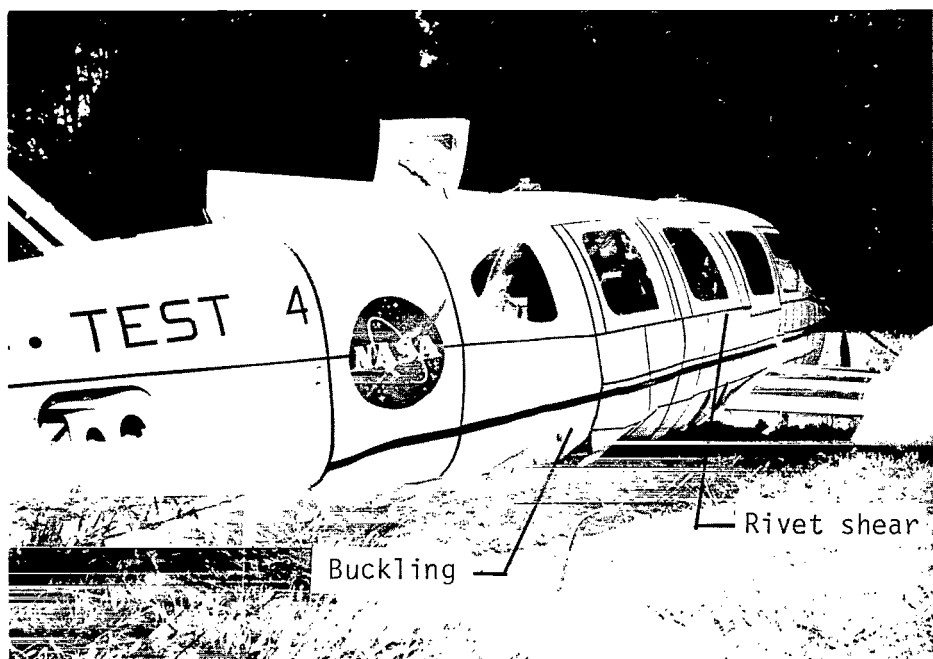
(a) Aft section damage on starboard side of fuselage.

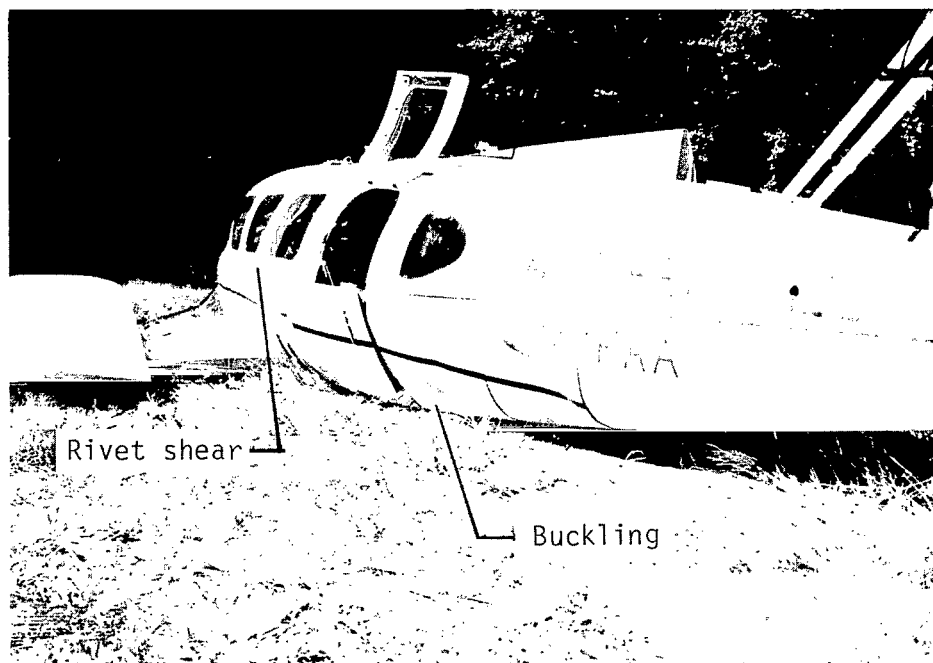
(b) Aft section damage on port side of fuselage.

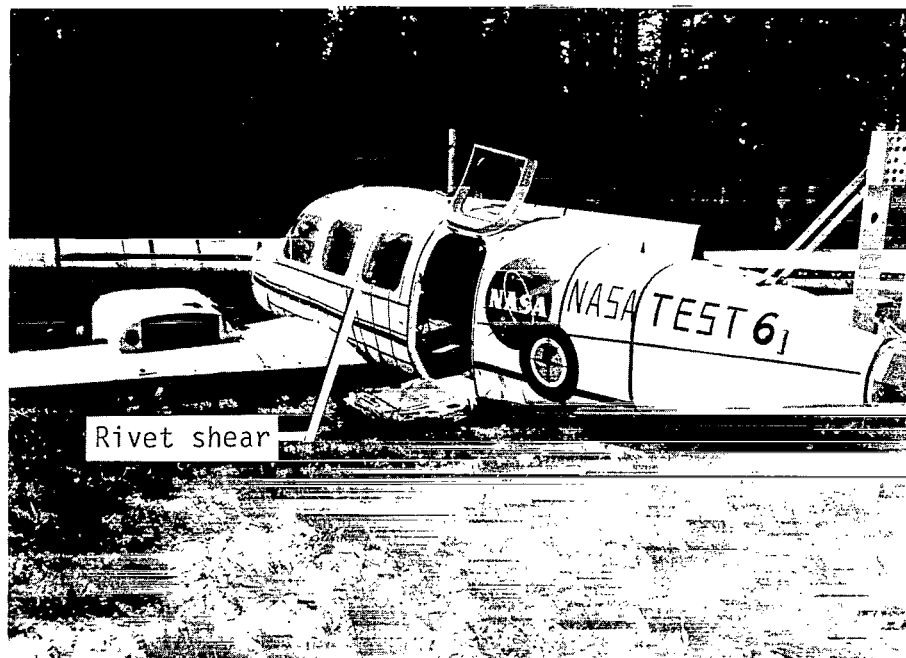
(a) Aft section damage on port side of fuselage.

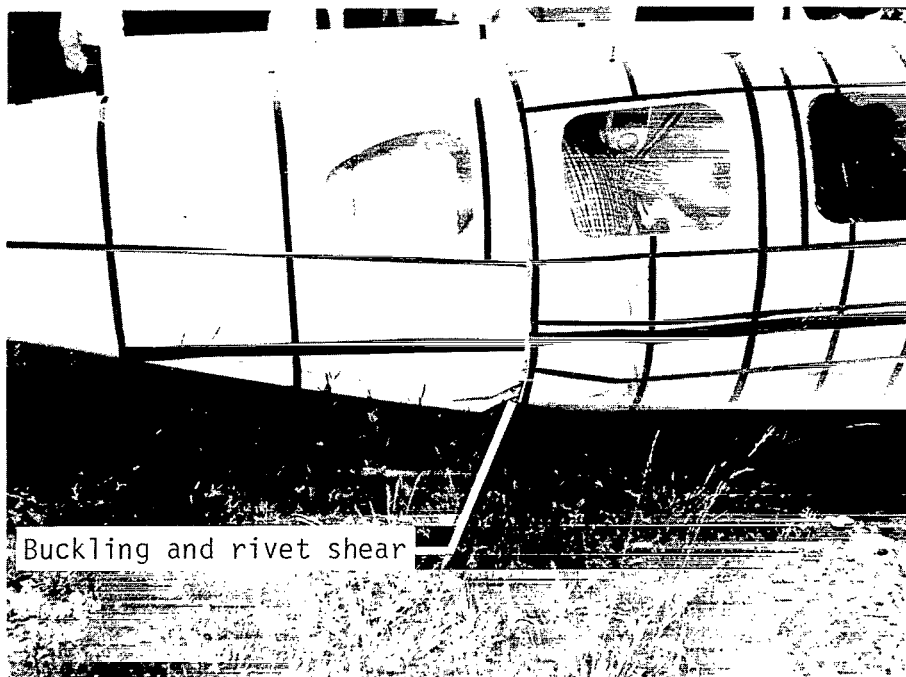
(b) Aft section damage on starboard side of fuselage.

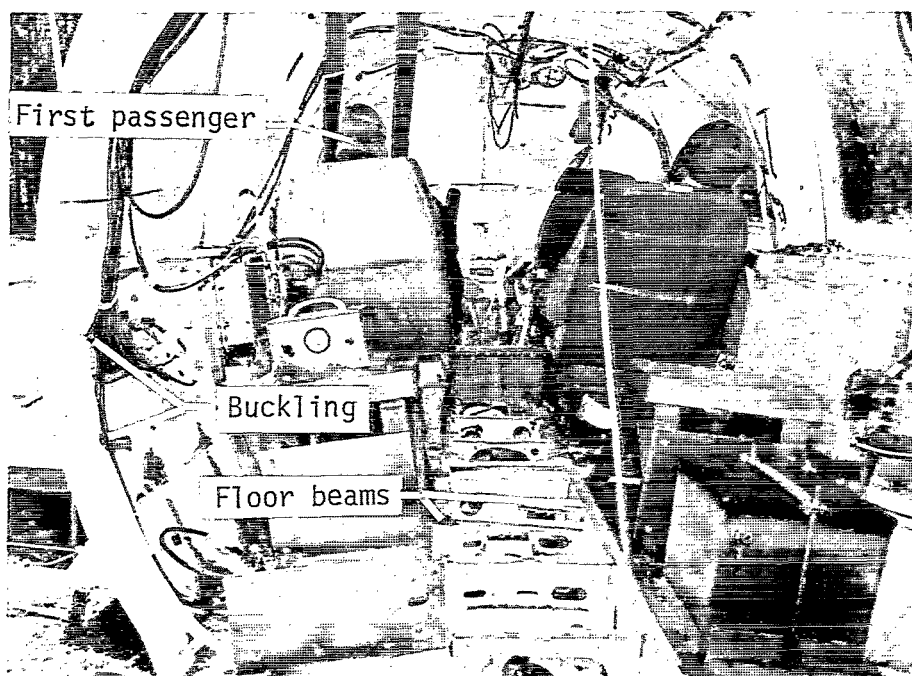
(a) View looking forward.

Pitch-down test.— The photograph from the pitch-down test (fig. 16(a)) was taken from the aft end of the fuselage looking forward. The intrusion of the floor structure into the cabin is shown by the outward rotated position of the seats. Because of the circular shape of the bottom of the fuselage, the out-

board floor structures were bent down around the two longitudinal floor beams which made first ground contact. Consequently the seats, dummies, and all items outboard of the floor beams rotated outward.

This rotation, together with the counterclockwise rotation of the pilot's body around the restraint strap crossing the left shoulder (fig. 9(a)), was responsible for the pilot's head impacting the side window, contributing to window breakage. The buckles in the door frame resulted from the transverse expansion of the fuselage during impact. The photograph taken from the pilot's position looking rearward (fig. 16(b)) shows only small buckles in the cross members between the floor beams and very little evidence of any damage in the aft section of the fuselage due to impact.

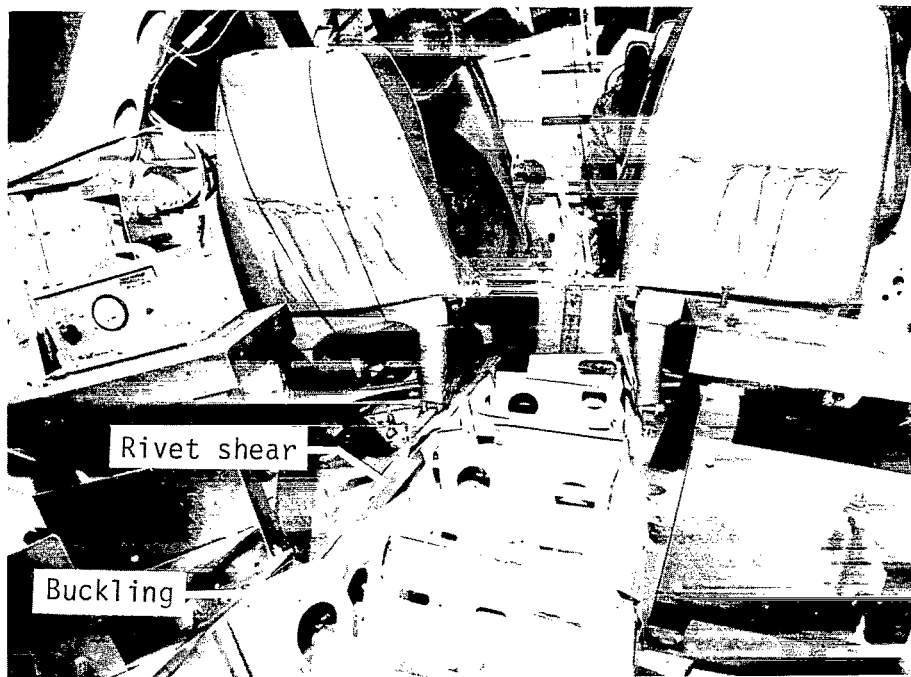
(a) View looking forward.

Flat test.— The photograph from the flat test (fig. 17(a)) was taken from the aft end of the fuselage looking forward. The outboard rotated position of the seats is much more pronounced than in the pitch-down test. The floor structure was pushed upward, with buckling and rivet-shear failures throughout the floor area. The longitudinal floor beams, which are fabricated from flat stock and extrusions riveted together, separated along the rivet lines. The photograph taken looking through the doorway at the structural damage in the vicinity of the fuselage where first ground contact occurred (fig. 17(b)) indicated that the floor structural damage was extensive and included buckling, rivet-shear failure, breaking, and tearing of the structure. This damage area extended back to the frame of the baggage compartment farthest aft, as shown in figure 17(c). The photograph (fig. 17(d)) shows a break in the main wing spar near the center of the fuselage.

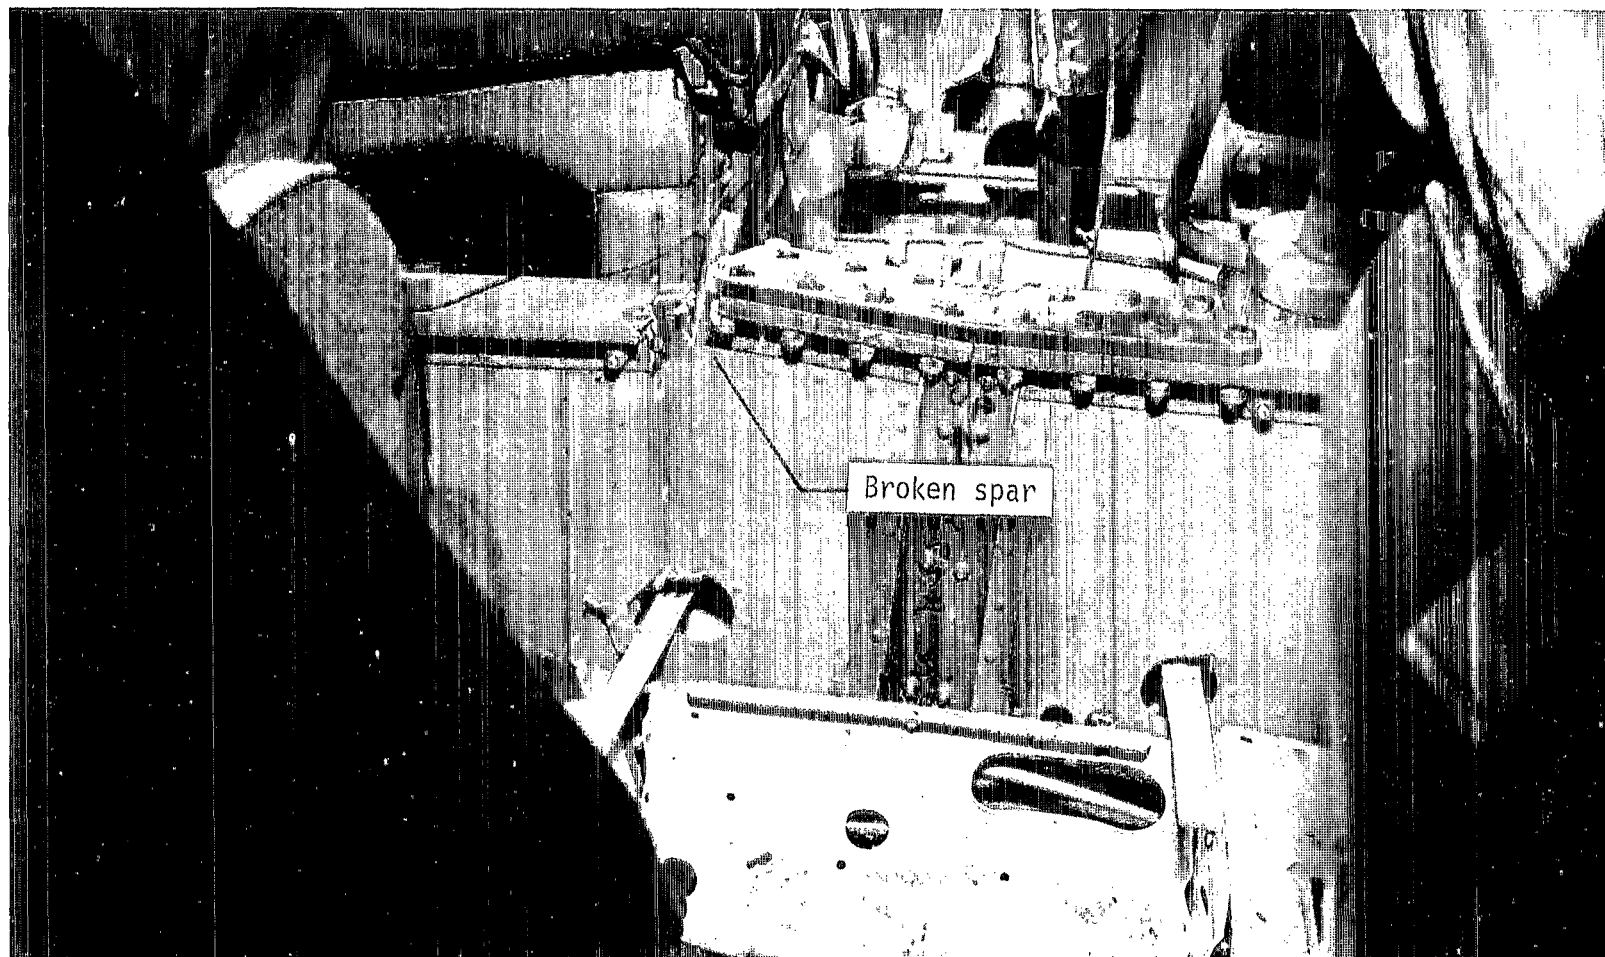
(d) View of broken main wing spar.

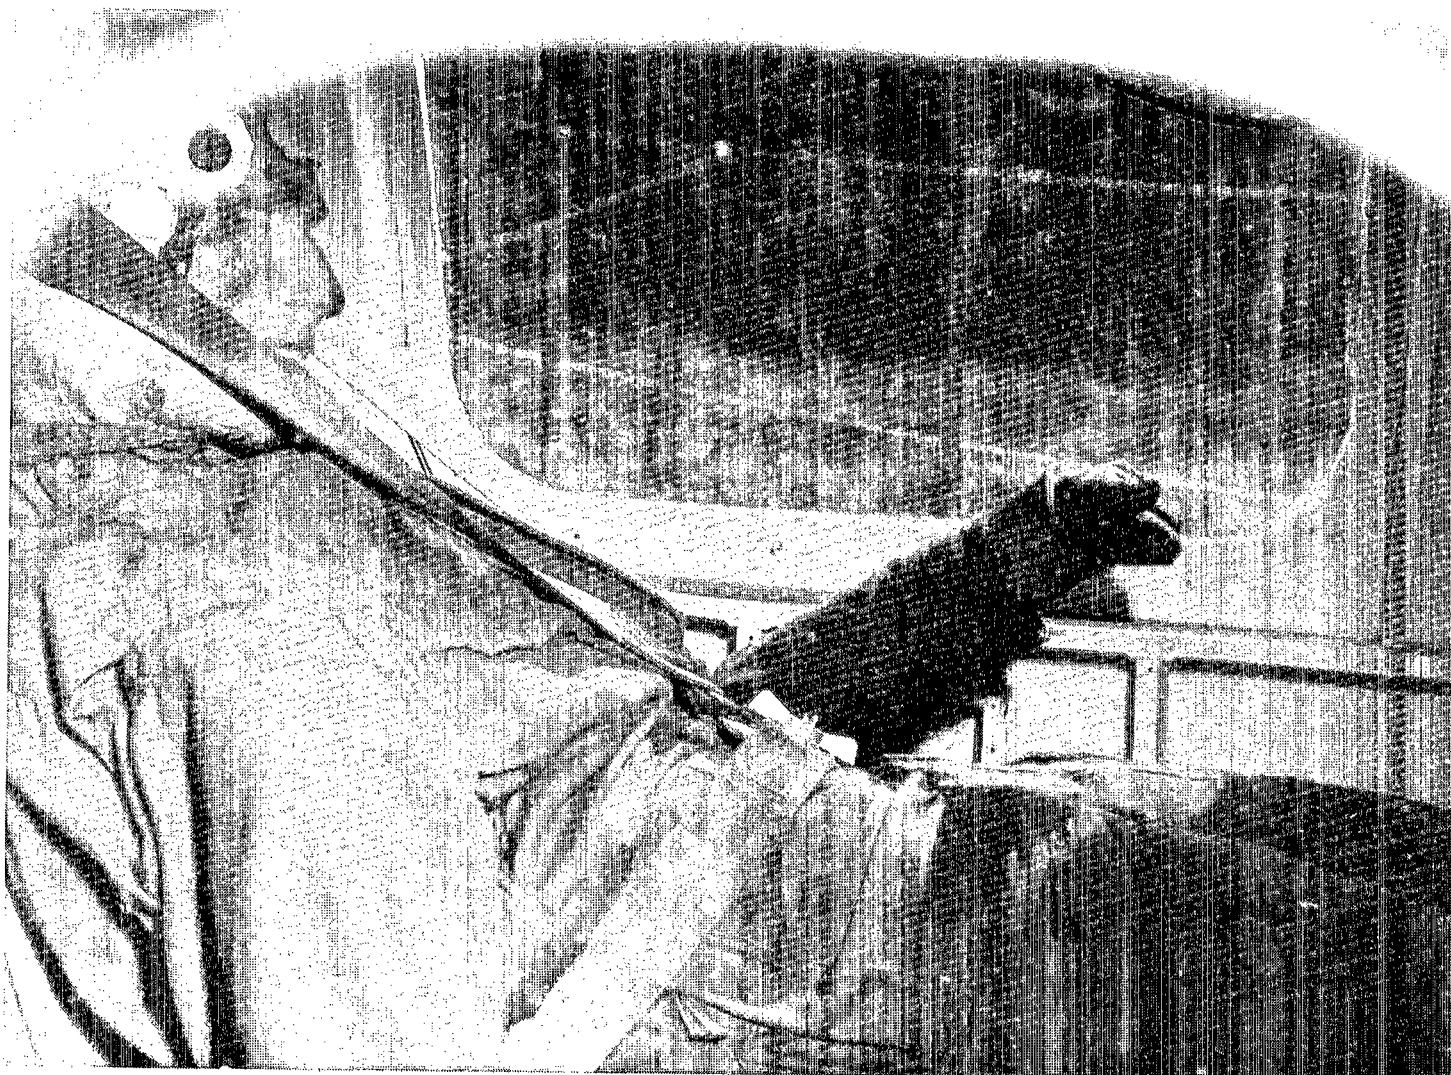
Figure 24.- Submarined position of first-passenger dummy in pitch-up test specimen.

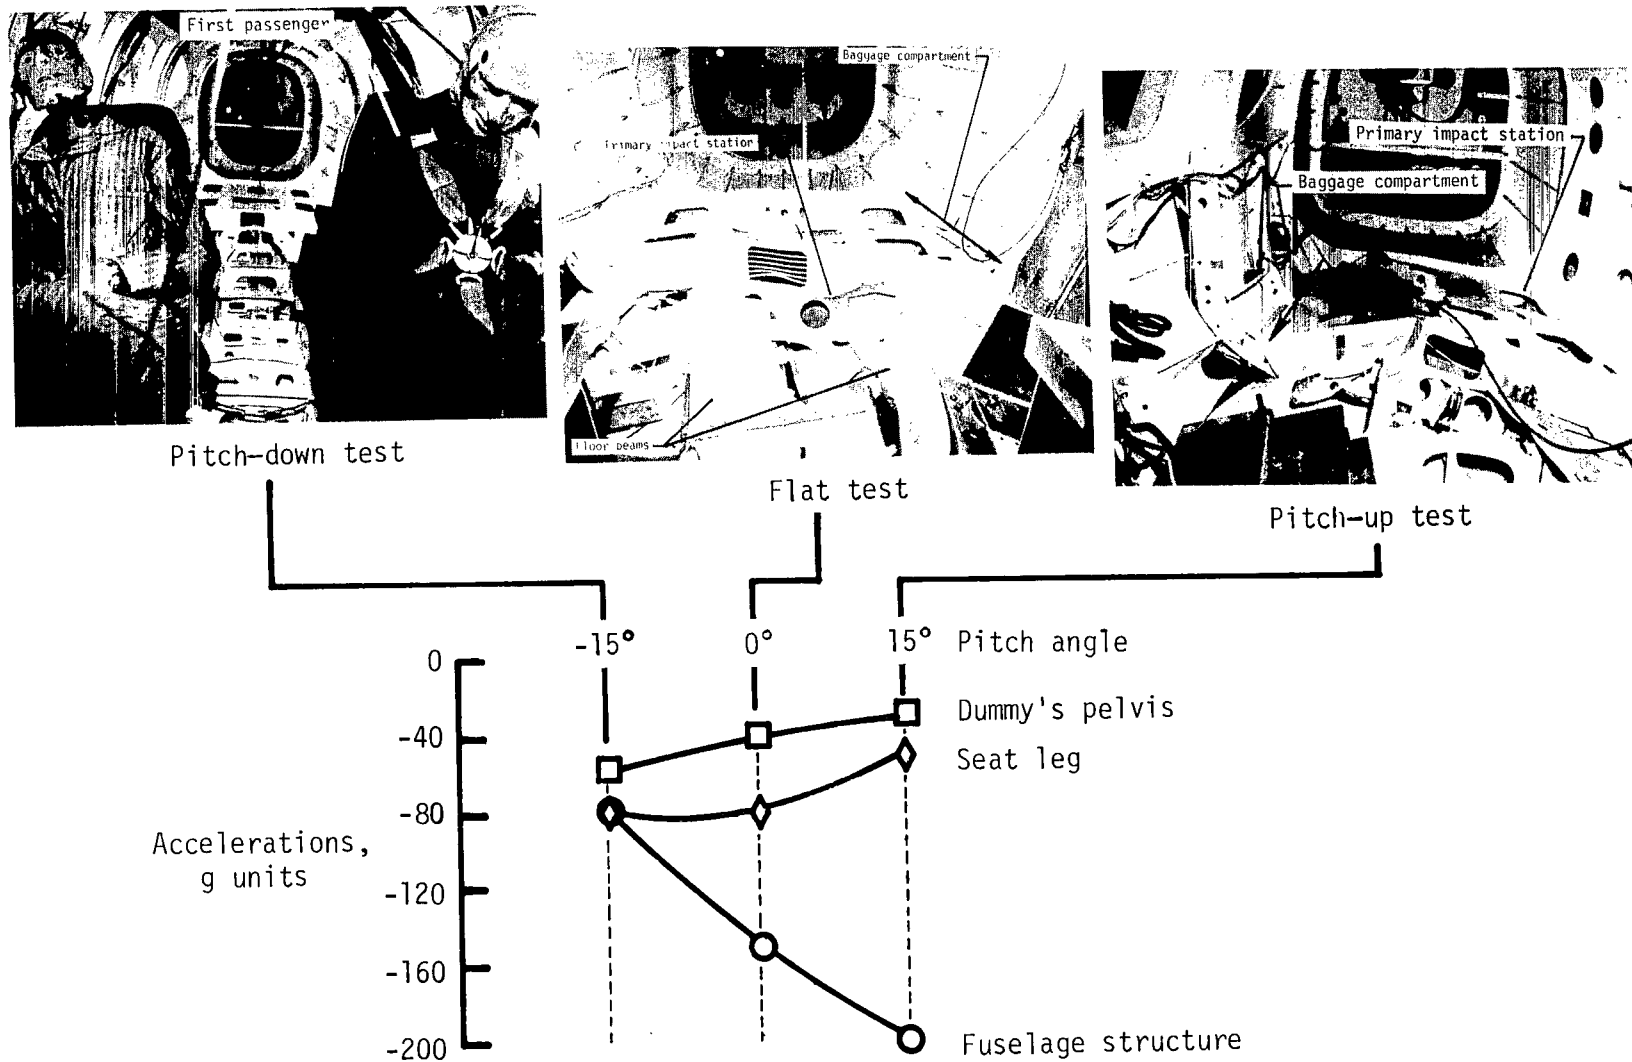
The difference in physical damage to the passenger compartments that accompanied these accelerations is presented by the photographs in figure 25. The damage increased from the pitch-down to pitch-up tests. The peak accelerations in the pelvic region of the first-passenger dummy decreased from -55g, to -40g, to -30g for the pitch-down, flat, and pitch-up tests, respectively. As the fuselage structural damage increased, peak pelvic accelerations in the first-passenger dummy decreased.

Figure 25.- Maximum normal accelerations in dummy's pelvis, on the floor at the first-passenger seat legs, and on fuselage structure.
